# HOME RESTORATION AND PRESERVATION OF 222 EAST SAN MIGUEL STREET

**Preserving the past for present and  
future generations to enjoy**

# Restoration Details

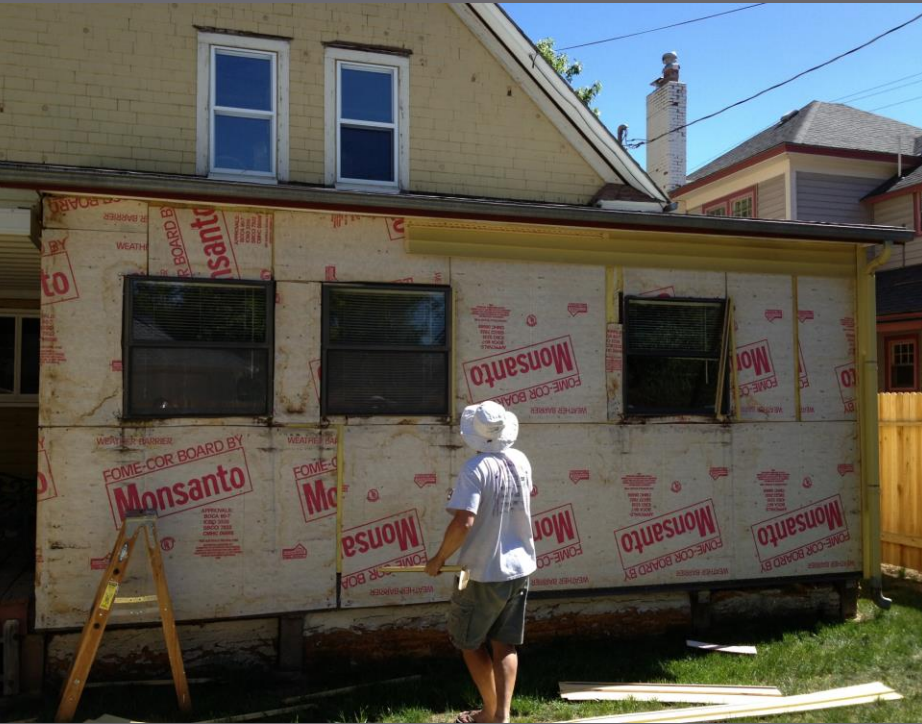
# 1 Vinyl Siding Removal

All but a few sections of vinyl removed from the 1979- '80 north addition

7. DESCRIPTION OF REHABILITATION		
1.	<p>Architectural Feature <u>Vinyl/Siding</u></p> <p>Describe feature and its condition:</p> <p><i>The house was encapsulated in the early 1980's with Yellow vinyl siding. After 30 years the vinyl was badly faded and cracked along the entire house.</i></p>	<p>Describe work/impact on feature:</p> <p><i>All vinyl siding was removed from the house. It held moisture against the siding, thus expediting the rotting of wood.</i></p>

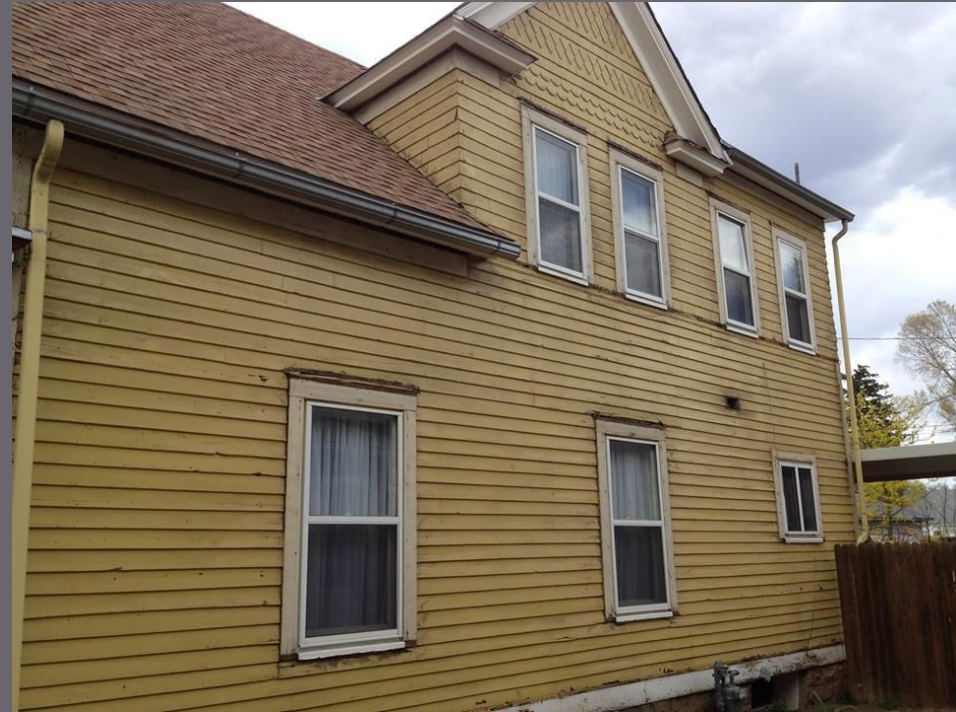
All vinyl siding removed leaving the original clapboard siding. Notice all of the nail holes in the clapboards

2.	<p>Architectural Feature <u>Clapboards</u></p> <p>Describe feature and its condition:</p> <p><i>The 1900 Clapboards were inspected after the vinyl was removed. All clapboards were in very bad condition - Cracked and water damaged due to vinyl siding.</i></p>	<p>Describe work/impact on feature:</p> <p><i>All 1900 Clapboards (Cedar) were replaced around the entire house. Cedar was used. All new clapboards were given two coats of primer back and front before installing on the house.</i></p>

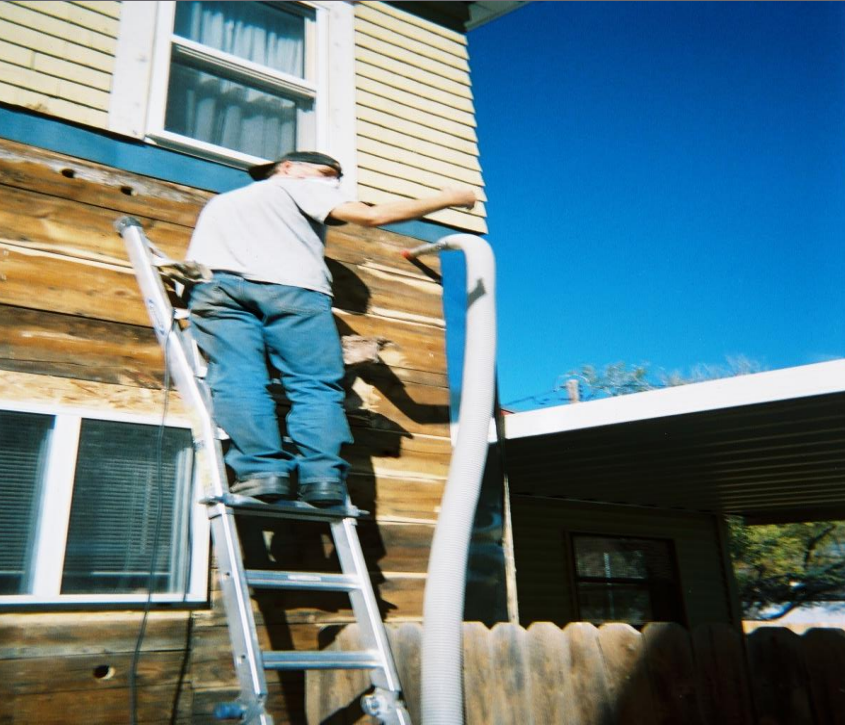
## 2 Insulation

Insulation is pumped into the walls-  
goodbye high utility bills, the need  
for AC in the Summer & space  
heaters in the Winter!

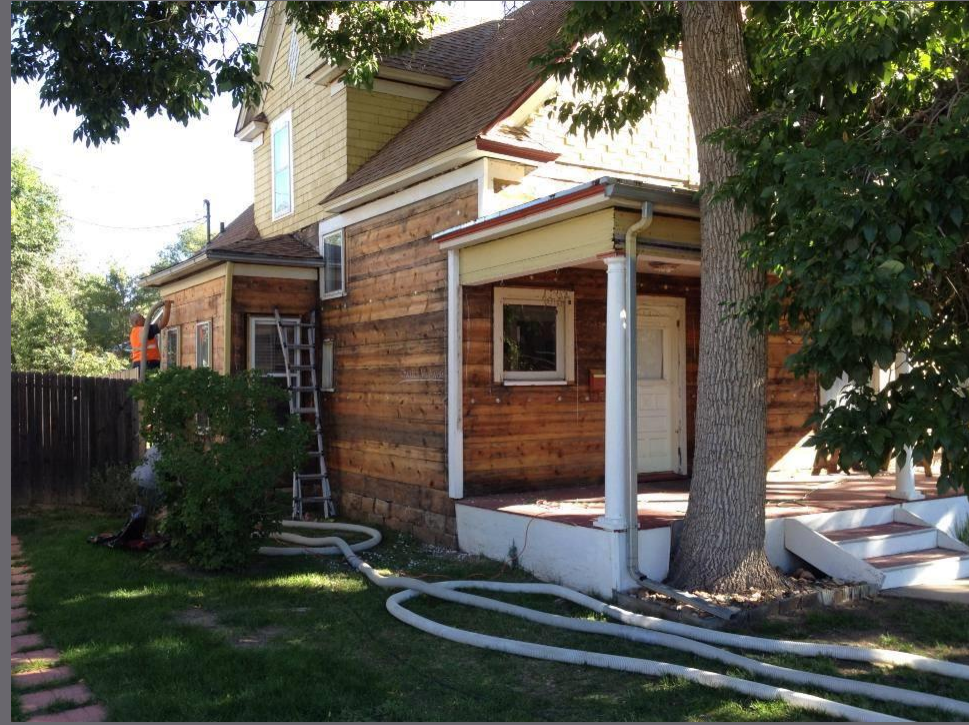
Holes were drilled and insulation  
blown into the entire house. So  
long to the 'Meat Locker' feeling  
during the Winter months!

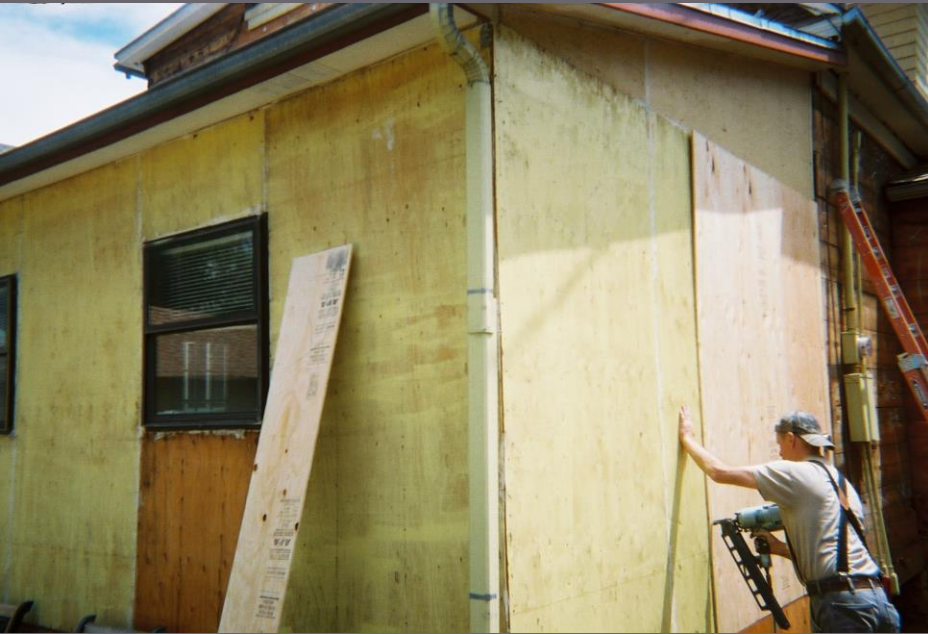
# 3 Monsanto Sheeting Replacement

Monsanto sheathing has been removed from the 1979-'80 addition and plywood is being nailed in it's place to match the 1900 sheathing boards

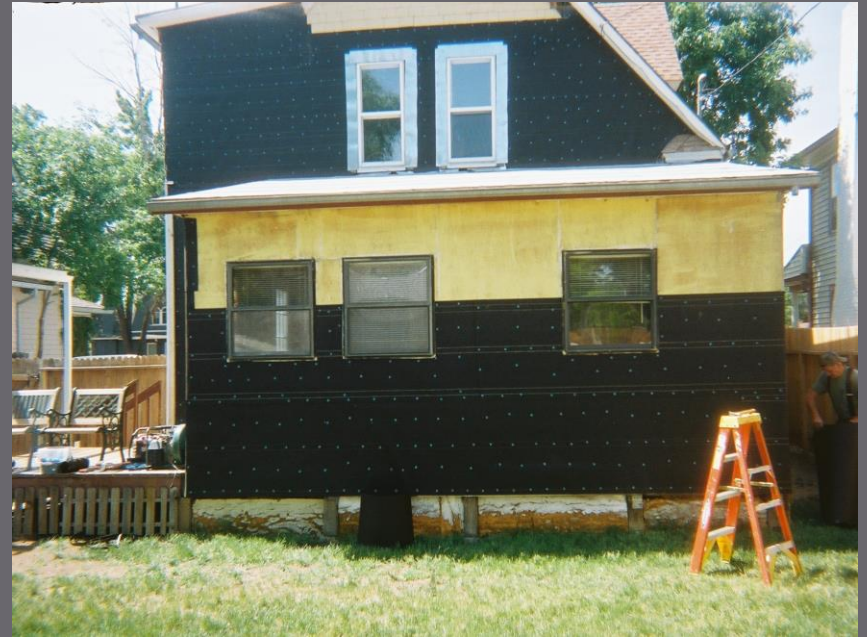
Plywood is in place and tar paper is nearing completion

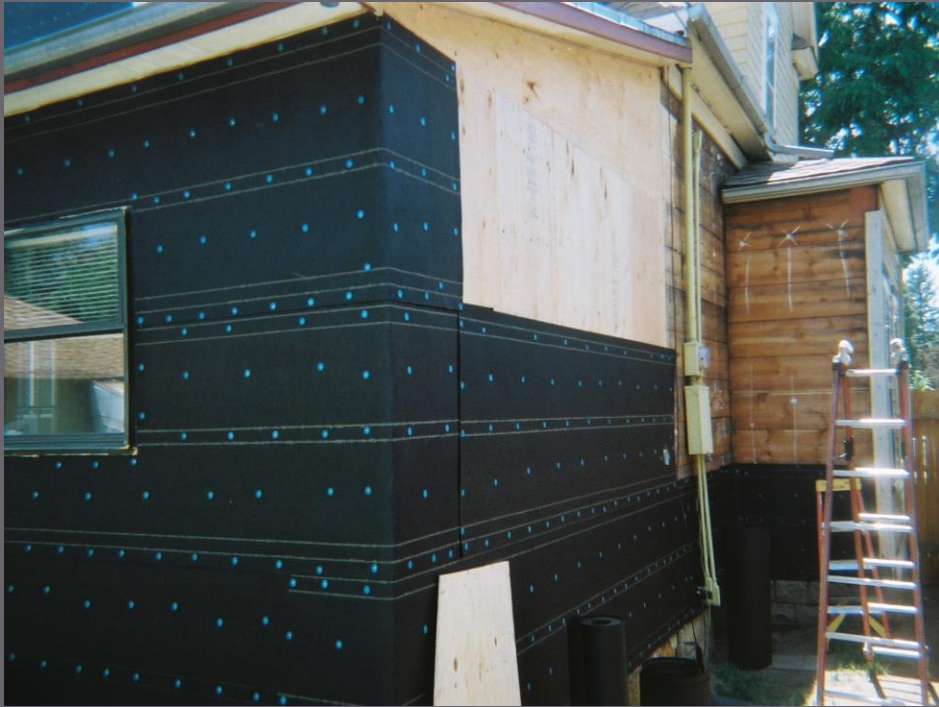
## 4 Tar Paper and Tin Flashing

Tar papering in Charlie's Cove

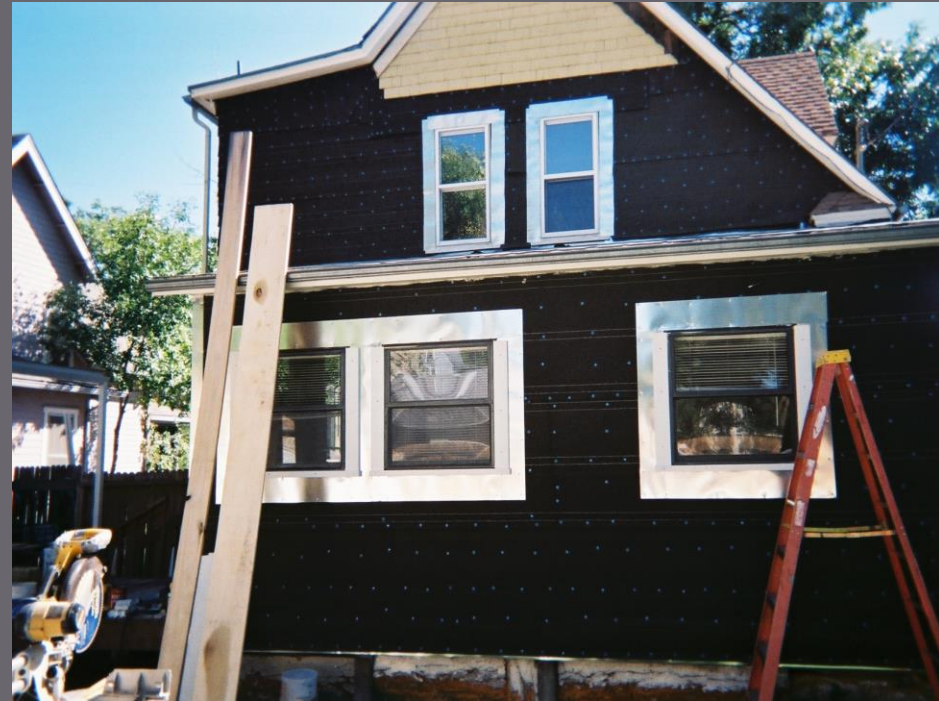
Tar paper in place and all windows and doors outfitted with tin flashing

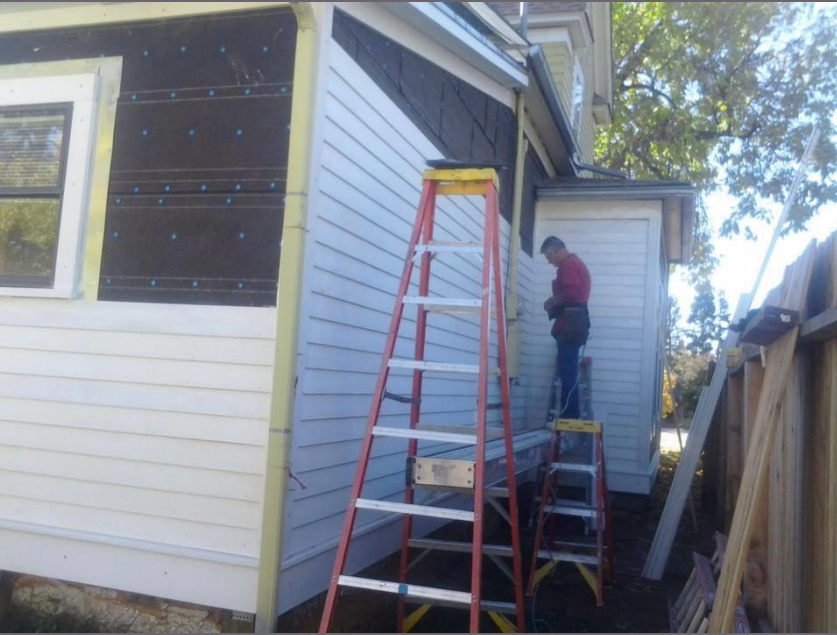
# 5 New Clapboards

New clapboard are being installed

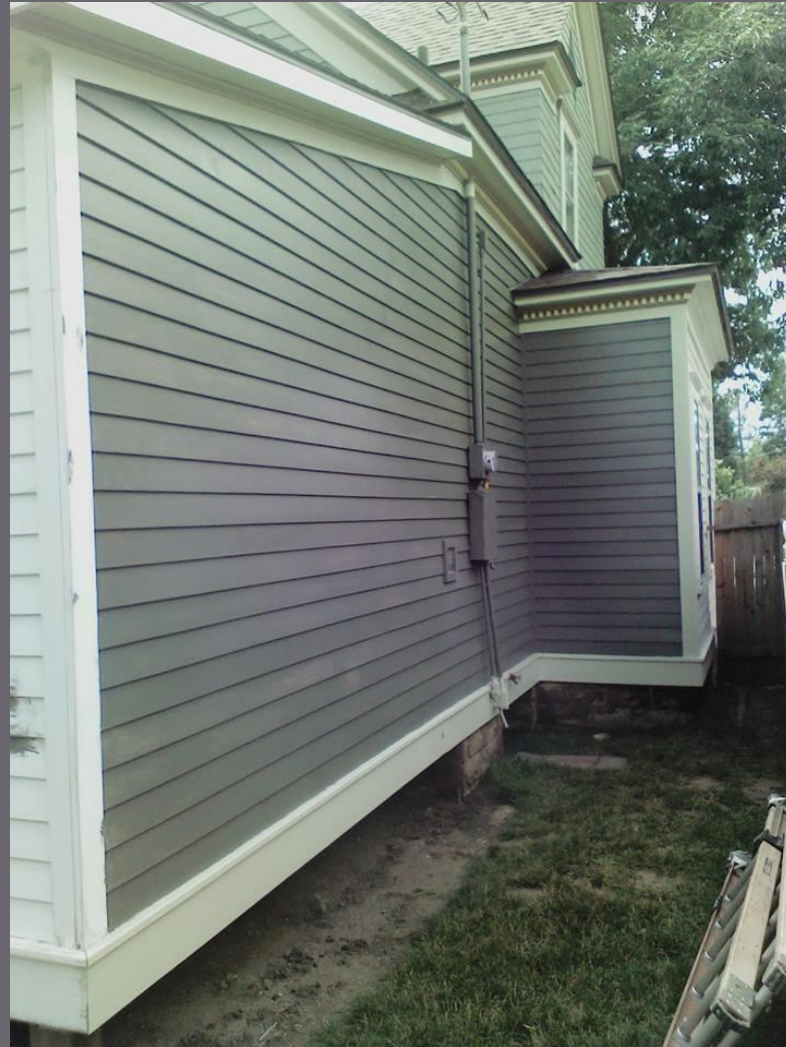
Clapboards in Charlie's Cove are painted

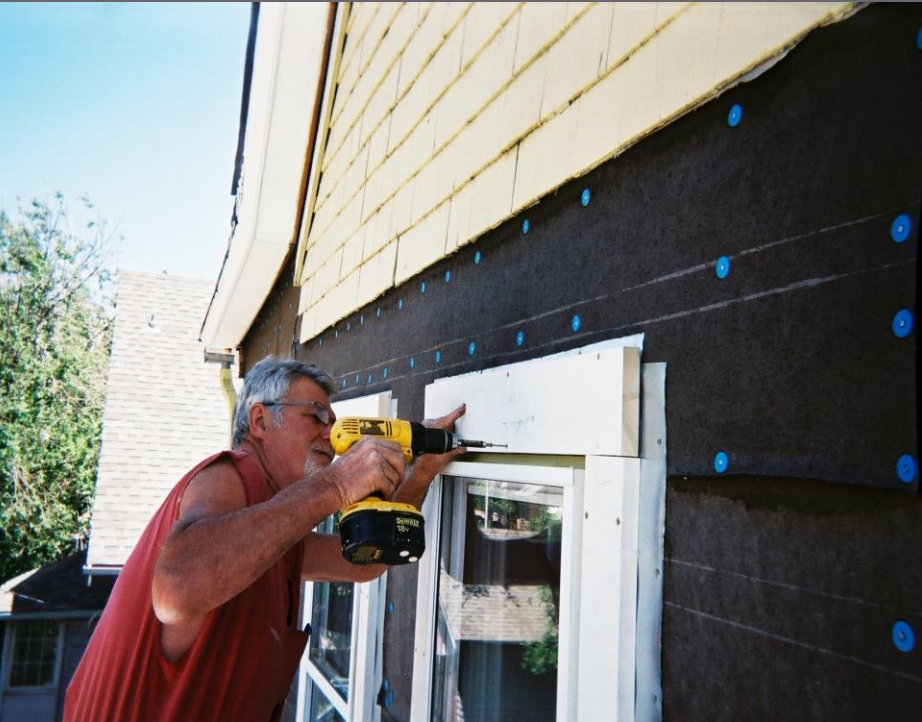
## 6 Window & Door Trim

Tar paper and tin flashing in place  
as the wood trim goes on

3.	<p>Architectural Feature <u>Window &amp; Door Trim</u></p> <p>Describe feature and its condition:</p> <p><i>All window and door trim pieces were in very bad condition. Split, cracked, water damaged and missing in some cases around the windows.</i></p>	<p>Describe work/impact on feature:</p> <p><i>Replace all window and door trim with poplar wood - same as used in 1900. All trim primed with two coats of primer, front and back before installing.</i></p>
<p>Photo no. _____ Drawing no. _____</p>

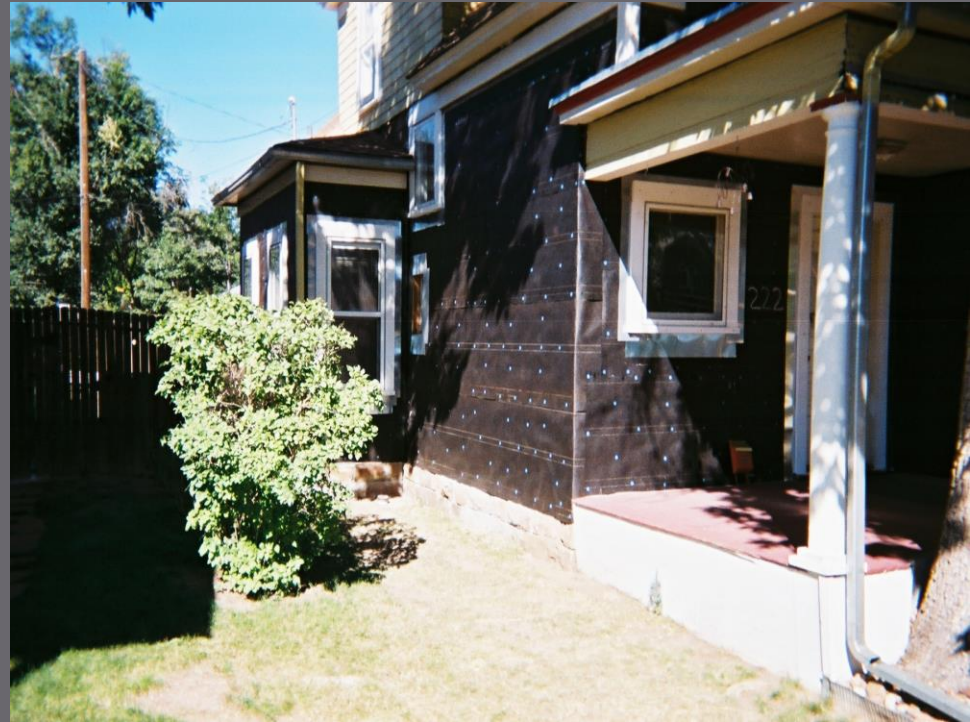
All windows and doors have new tar paper,  
tin flashing and trim boards installed

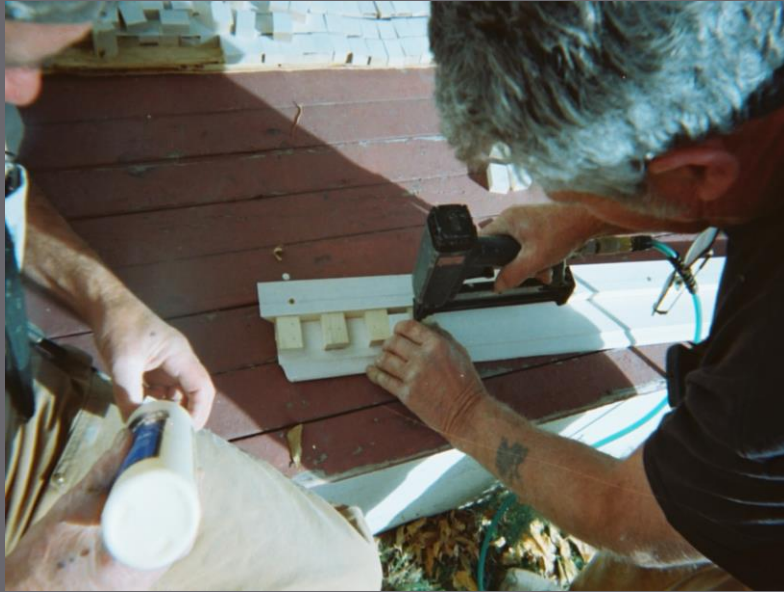
# 7 Dentil Molding & Trim

A majority of the dentil molding came from the Stearman house while some had to be made, as seen here

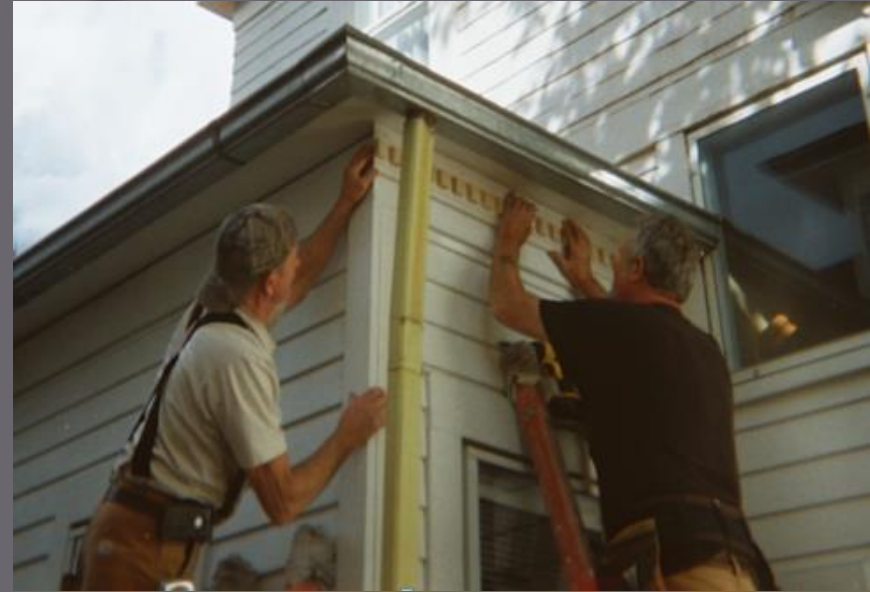
Installing dentil molding

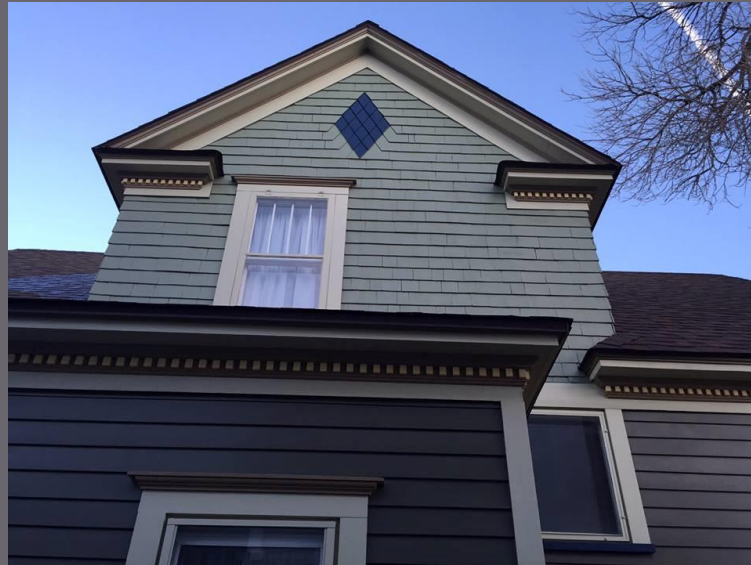
The finished dentil molding in place and painted

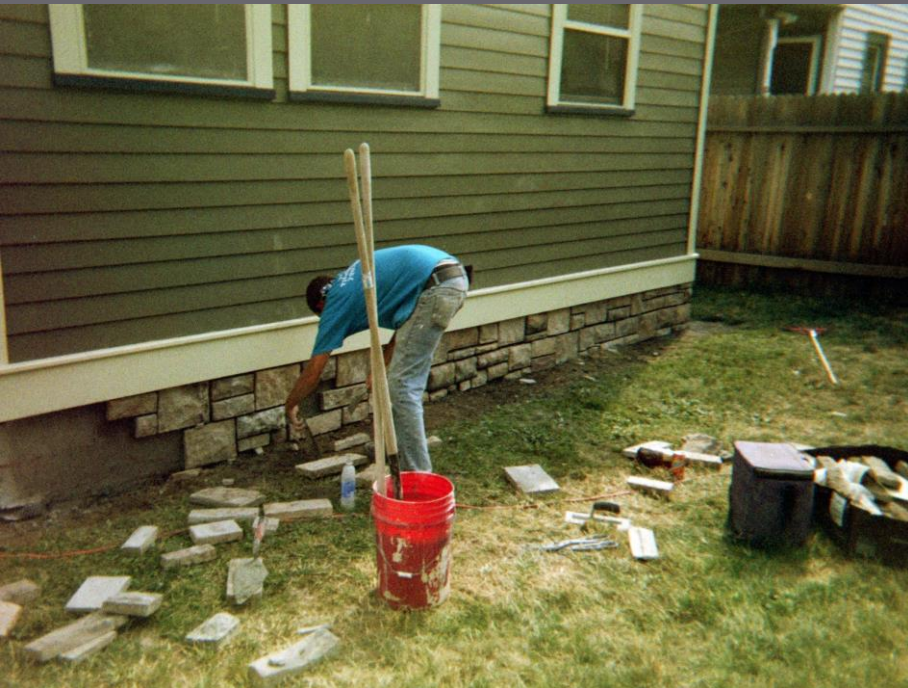
# 8 New Foundation Stone

Building the new foundation wall with 'Cut Stone' to differentiate from the 1900 foundation

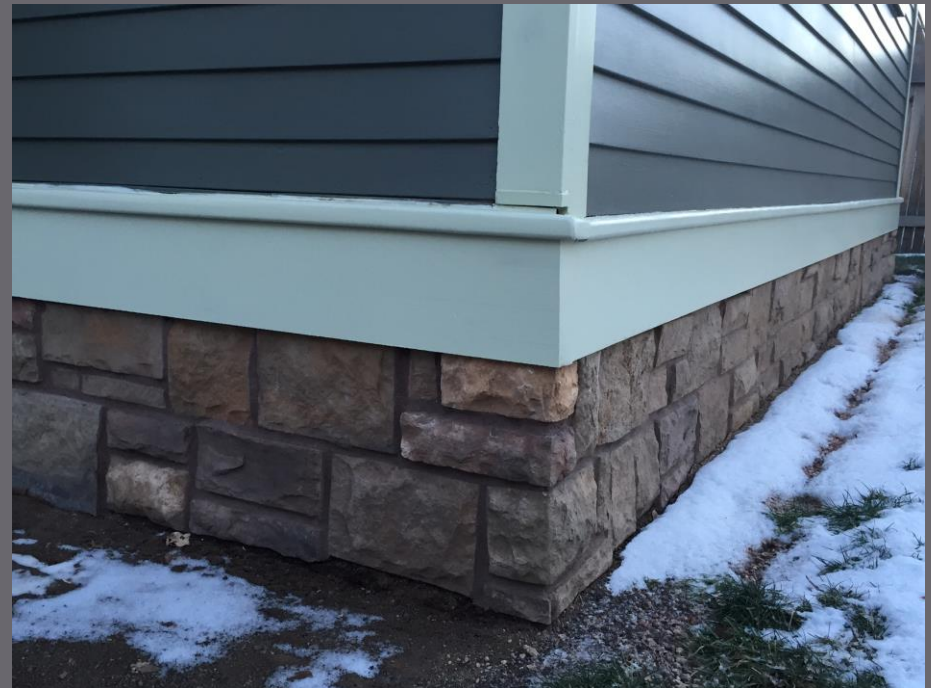
The finished product- looking south into Charlie's Cove, 1979-'80 meets 1900

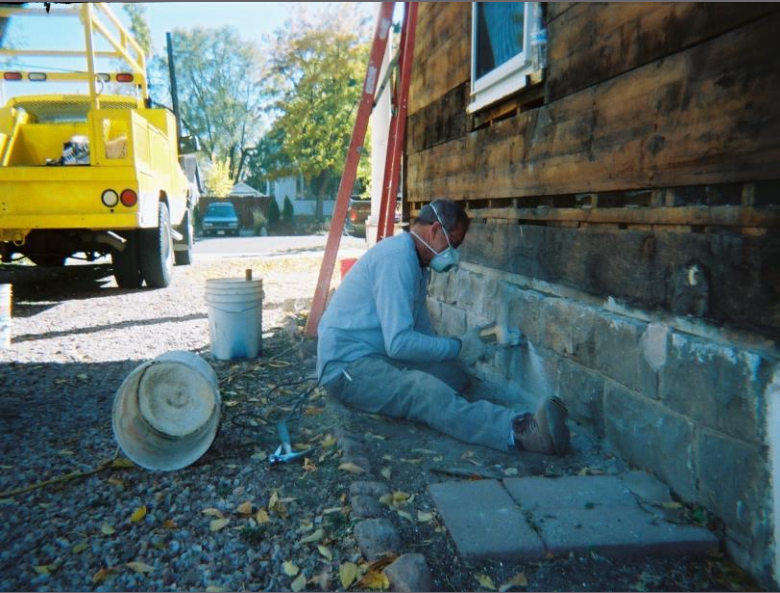
## 9 Foundation Pointing

Grinding old mortar out

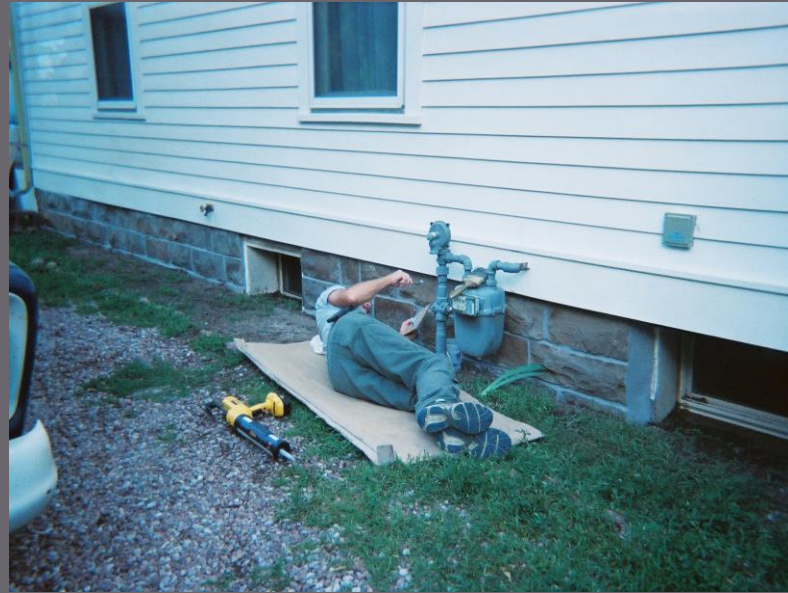
Battery caulking gun to apply final material

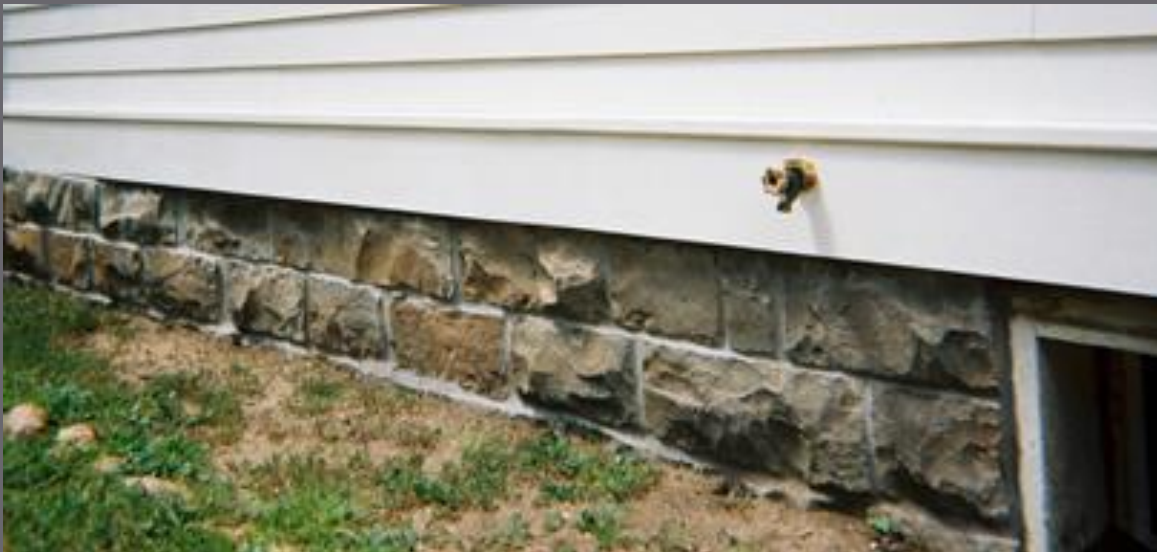
The finished product

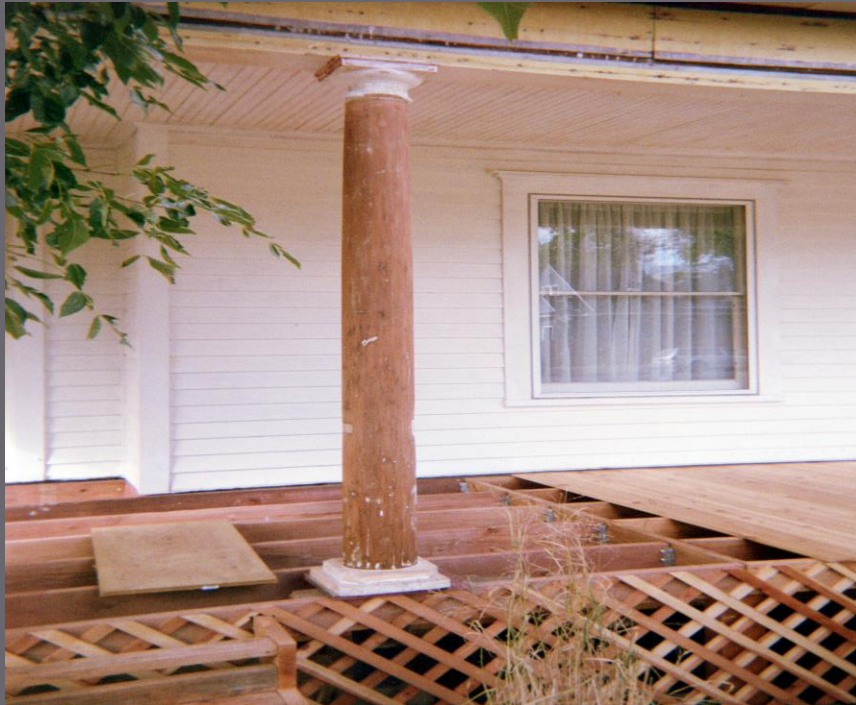
## 10a Porch Deck & Columns

New porch decking in progress. The columns were stripped in place as not to disturb them

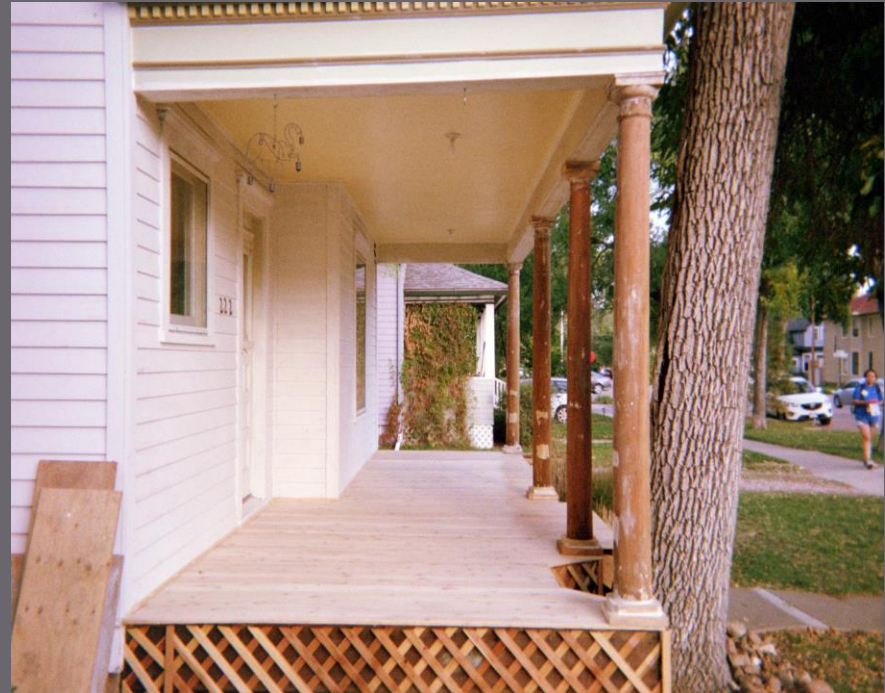
Columns have been restored in place - are now ready for primer & painting

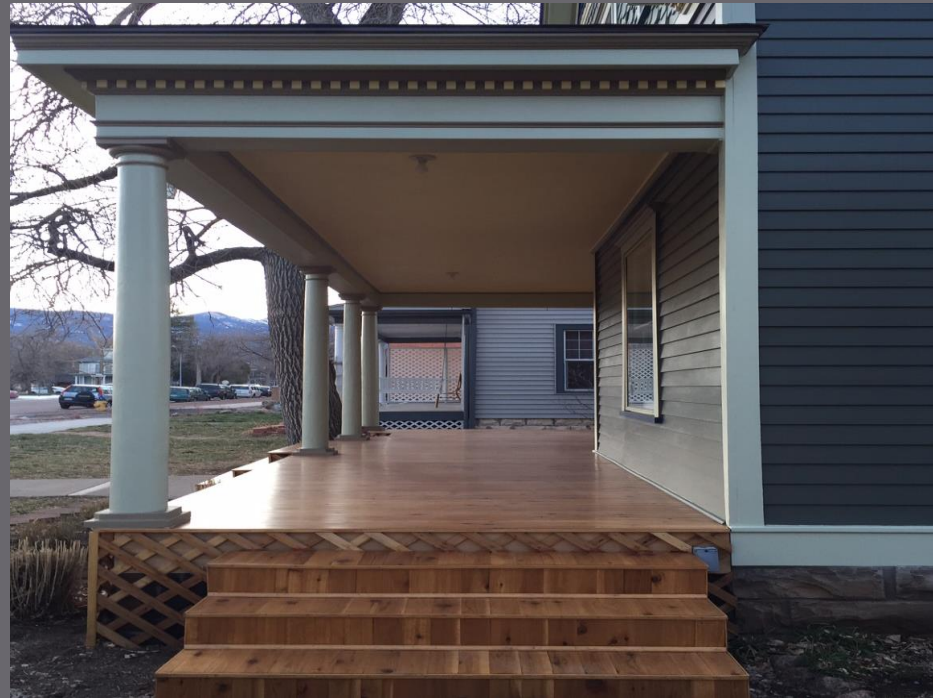
The porch is done!

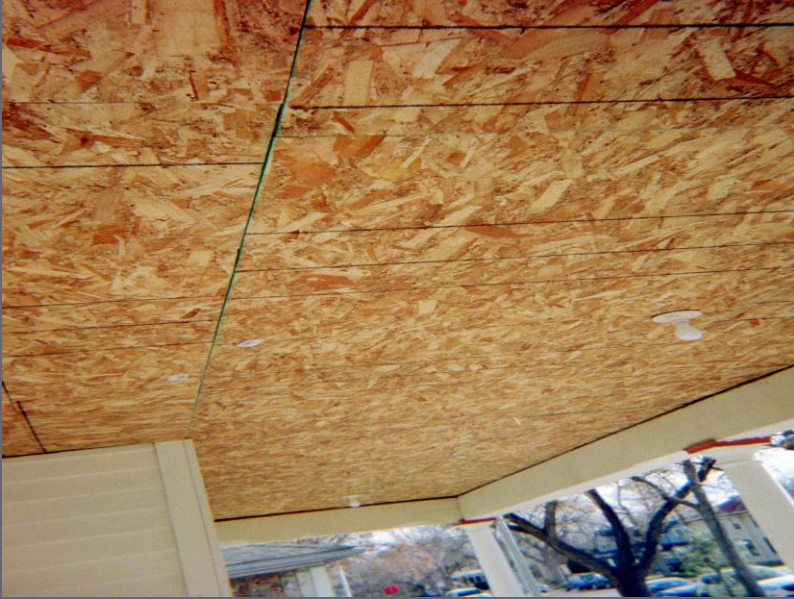
## 10c Porch Ceiling

OSB in place – ready for primer & bead boards

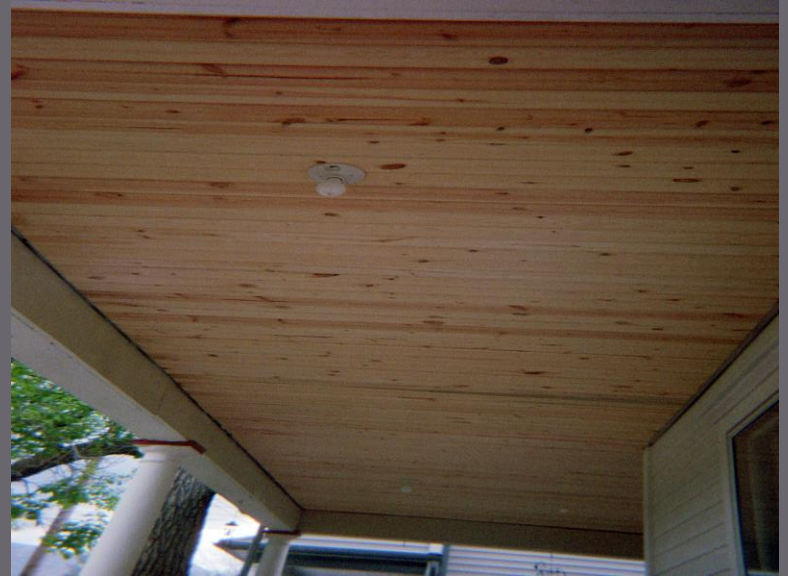
Tongue & groove knotty pine bead boards in place – ready for primer & paint

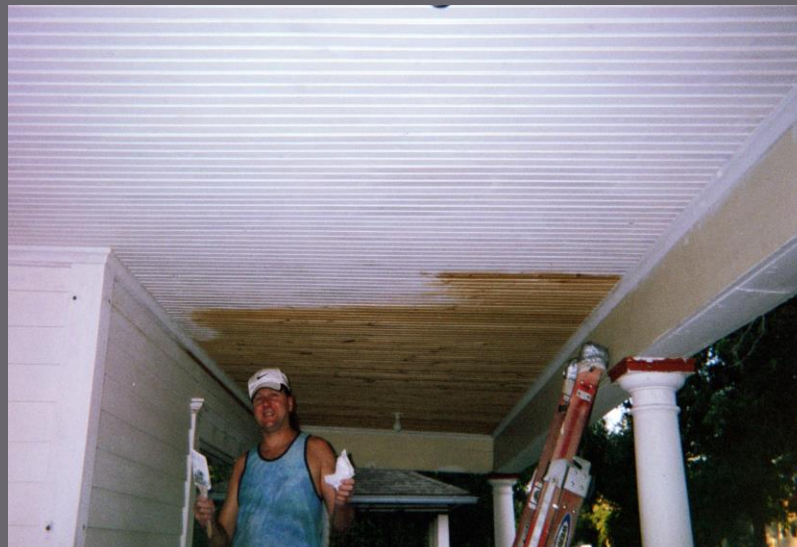
Priming in progress by my buddy Mike
